BALTIMORE INNER HARBOR, PIER 5  
South side of Pratt Street, between  
Market Place and Concord Street  
Baltimore City  
Maryland

HAER No. MD-86-A

**Baltimore Inner Harbor, Pier 5**

Significance: Designed by Oscar F. Lackey and constructed in 1908-1910, the bulkheads on Piers 4, 5, and 6 in the Baltimore Inner Harbor were among the first reinforced concrete structures erected in seawater in the United States. These and other early concrete piers in the U.S. pioneered the acceptance of reinforced concrete in American harbors. The solid piers, consisting of filled reinforced concrete bulkheads, played a significant role in the evolution from timber pile to reinforced concrete for seawater construction.

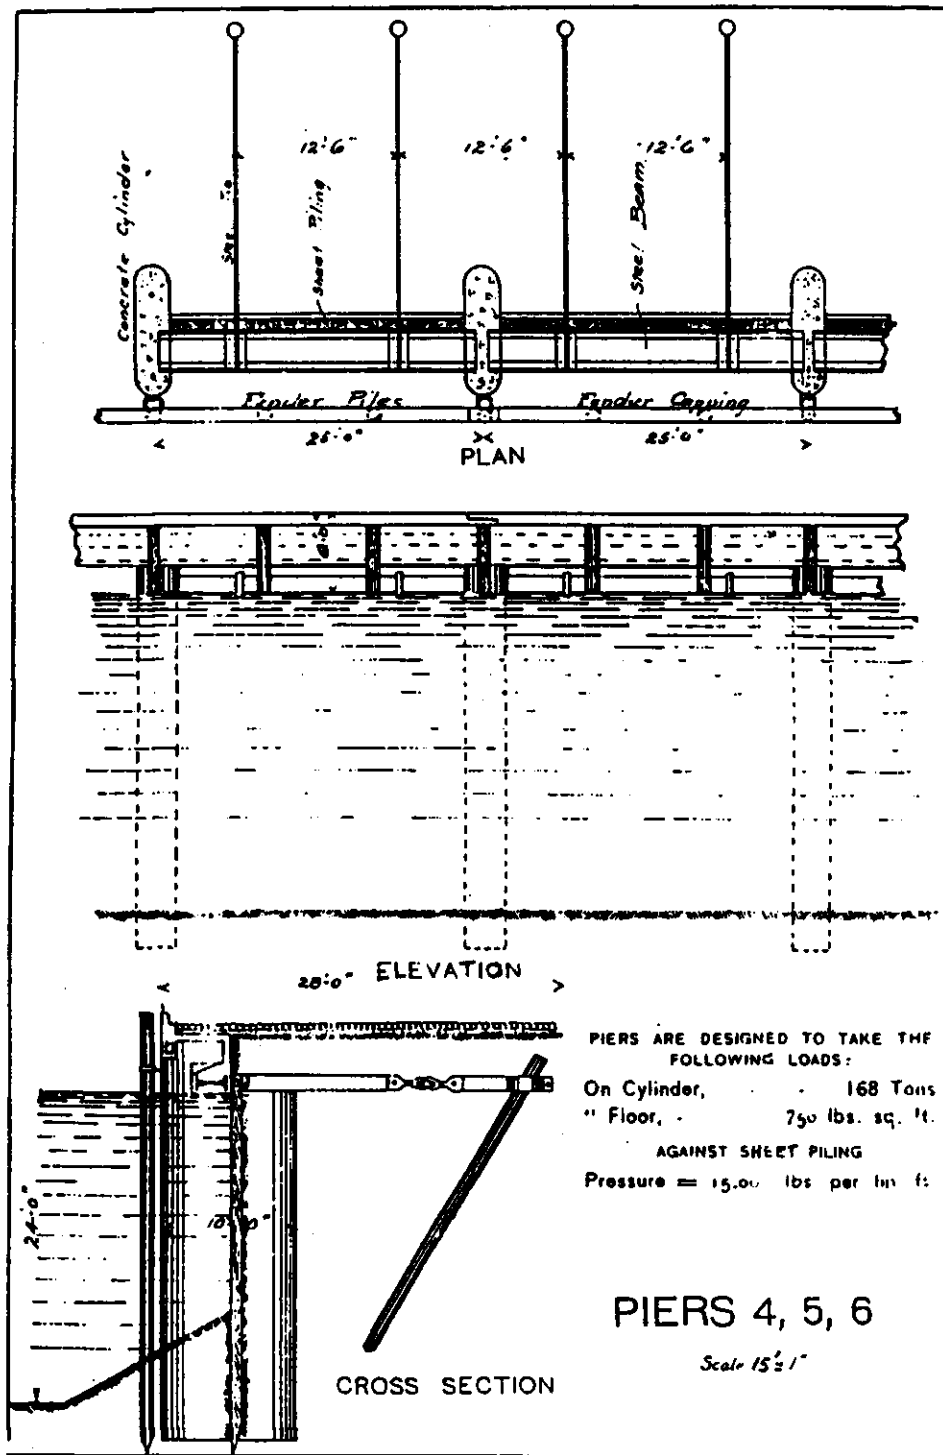
PLATE 1

Initial Design of Piers Prior to Modification for  
Existing Conditions on Pier 4

SOURCE: Harbor Board Report for 1907

The most detailed description of the construction of the piers can be found in a description of Pier 4, the first to be constructed:

steel cylinders, with a cross section 3 feet by 10 feet and 27 feet long, were first driven in 4 foot sections, held together by angles, with additional angles running longitudinally from top to bottom, to prevent collapsing (sic) from water pressure. These cylinders are placed every 25 feet on centers. After these cylinders were set in place, beld by wooden frames, and allowed to settle from their own weight of 7 tons; the material in the interior of the cylinders was removed about two feet below the cutting edge of the cylinder, by a centrifugal pump. The cylinders were then driven to refusal, pumped again, and then driven to the final penetration, and filled with a mixture of 1-3-5 concrete. After the cylinders were driven, lattice girders built of 6 inches, by 6 inch by 7/8 inch angles were anchored from cylinder to cylinder and wrapped with wire fabric, and covered with about 3 inches of concrete to protect the steel, after which reinforced concrete sheet piles 12" by 18", weighing about three tons were driven behind the girders. [Sheet piles were 27 ft. long.<sup>27</sup>] After the sheet piles were driven, two 15 inch channels carrying the front of the wall, and guard rail were

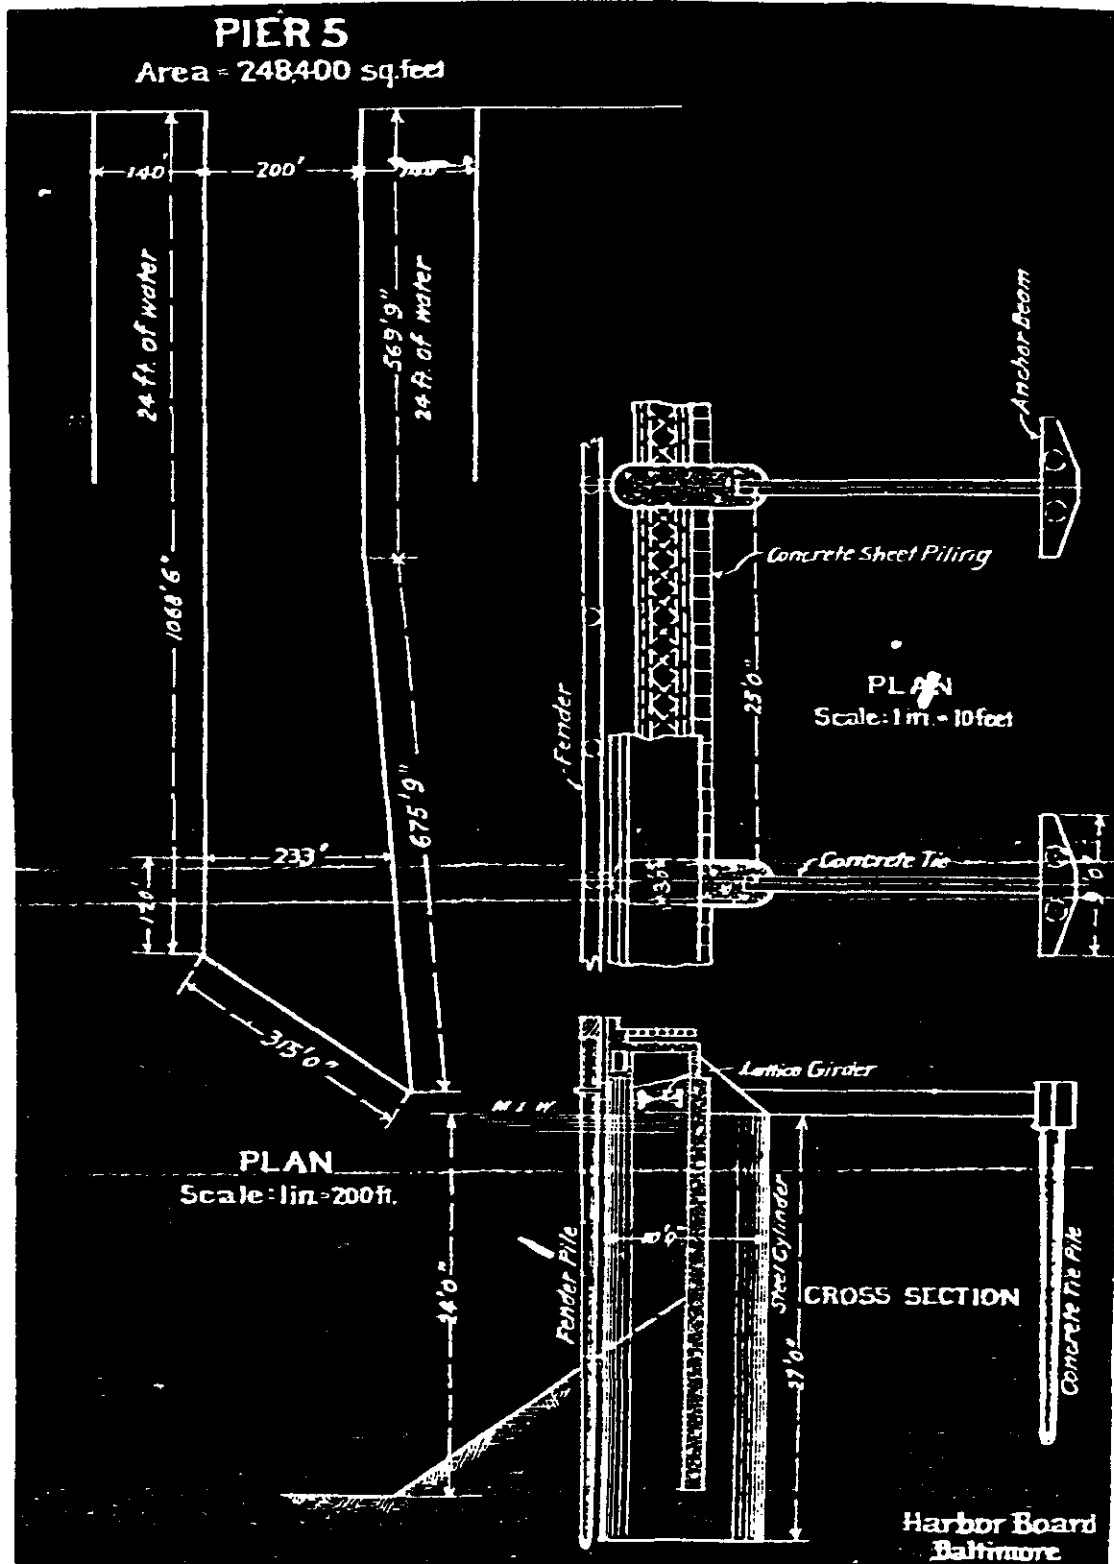
SOURCE: Survey of the Port of Baltimore (1920)
